{ REPORT
{ 99-1016

INVESTIGATION OF THE CHALLENGER ACCIDENT

R E P O R T

I. INTRODUCTION

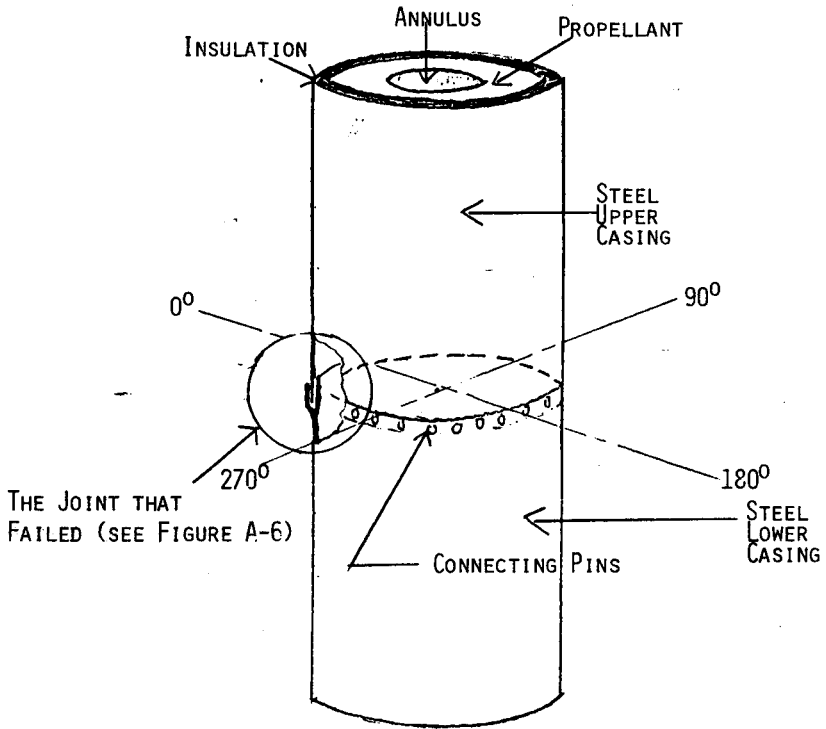
FIGURE V-5

Considerable reference will be made to the "joint design" throughout this section of the report. Consequently, the following description of the joint is provided. (See Figures V-5 thru V-7.)

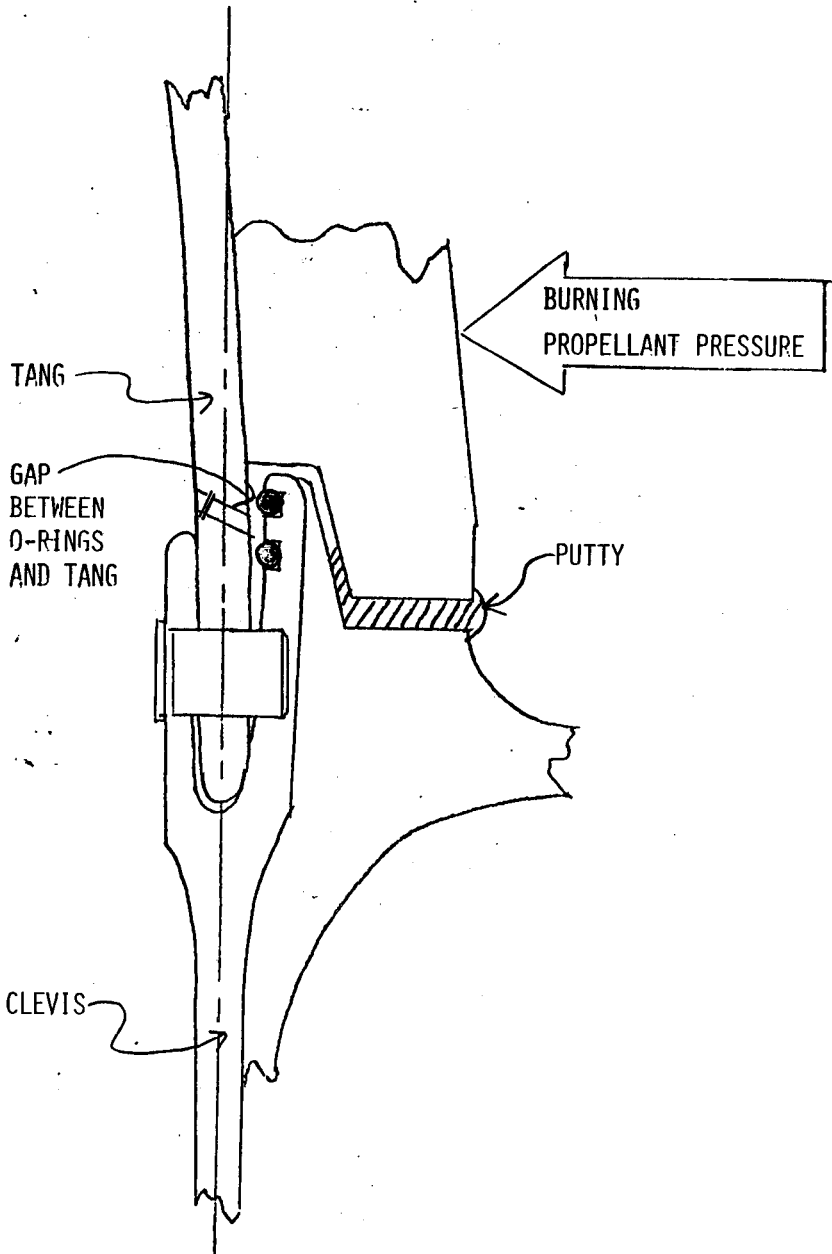
FIGURE V-7

B. JOINT ROTATED
(OUT OF ALIGNMENT)
